Oyster Reef Management in Apalachicola Bay

Jonathan Brucker
Central Panhandle Aquatic Preserves
March 11, 2020

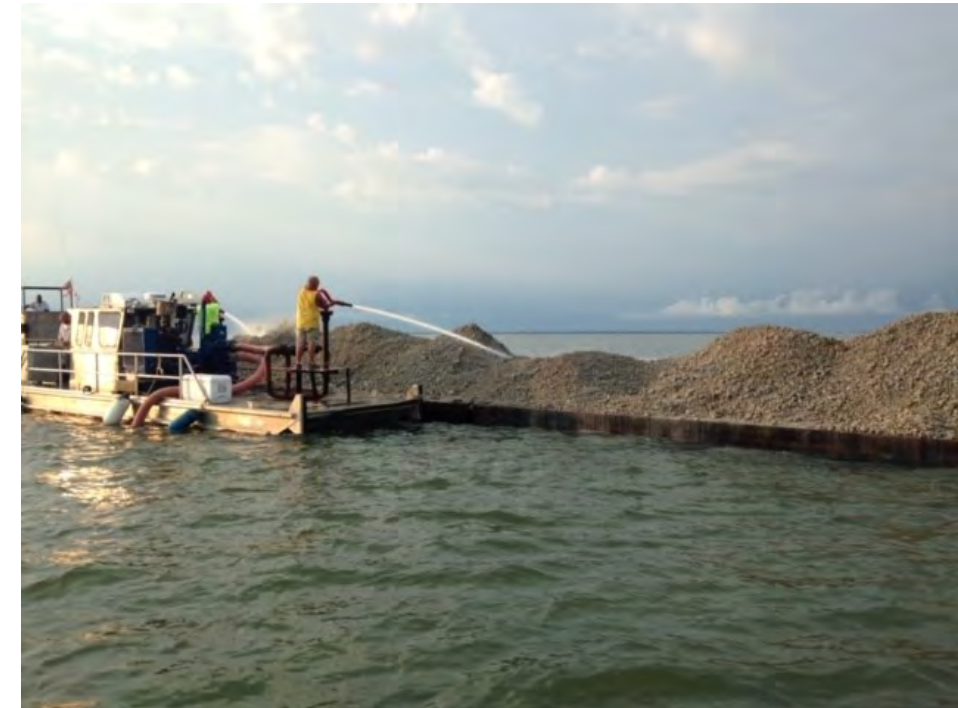
- To promote reef development for oysters by restoring existing oyster reef habitat that had been degraded, depleted, or reached its productive life span.
- The placement of suitable cultch material on existing oyster bars for the setting of native oyster larvae and oyster colonization is a widely accepted management practice.
 - Cultch – any suitable hard substrate suitable for the attachment of settling oysters (spat).
- Placing cultch material in areas where natural reproduction occurs:
 - Creates three-dimensional reef structure
 - Stimulates spat setting
 - Accelerates the recovery process
 - Increases natural productivity
 - Sustains oyster fisheries
 - Enhances ecosystem community functions

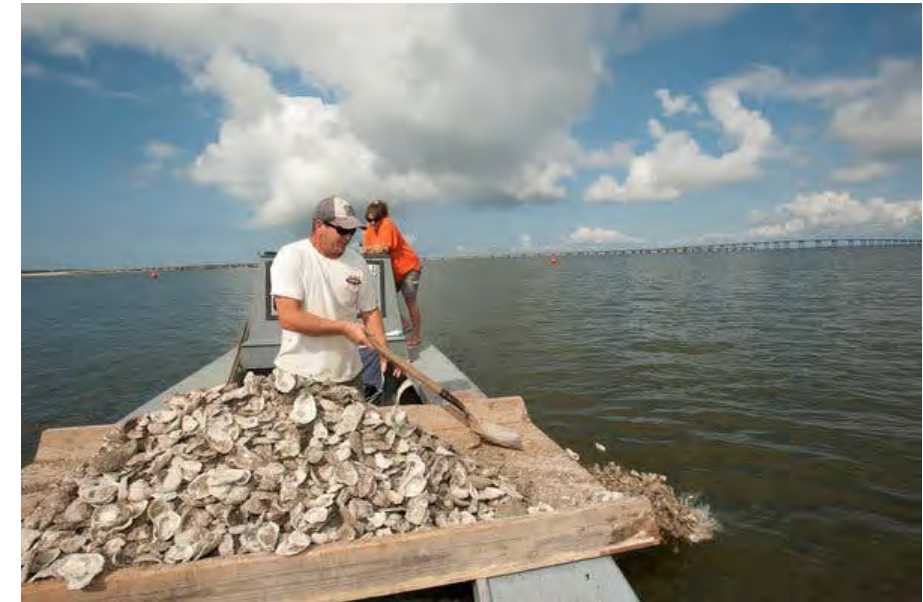
- **1999-2004**: 44,674 yds³ of processed shell (179 acres @ 250 yd³/acre)
- **2005-2007**: Cultching activities only occurred in Escambia, Santa Rosa, and/or Bay counties

- **2008-2012**: 44,556 yds³ of processed and fossilized shell (178 acres @ 250 yd³/acre)
- **2013**: No contractual cultching activities
- **2014**: 6,125 yds³ of fossilized shell (30.5 acres @ 200 yd³/acre)

- **2015**: Natural Fish and Wildlife Foundation (NFWF) Cultch Density Study
 - 3,000 yds³ fossilized shell at three experimental sites
 - Five 2-ac parcels were cultched at different shell densities (0, 100, 200, 300, & 400 yd³/ac)

- **2015**: Natural Resource Damage Assessment (NRDA) Oyster Cultch Recovery Project
 - 24,840 yds³ fossilized shell on 16 debilitated oyster reefs (124 acres @ 200 yd³/acre)

- **2017**: Gulf Coast Ecosystem Restoration Council (GCERC or RESTORE)
 - 95,500 yd³ lime rock aggregate on 14 debilitated oyster reefs (317 acres @ 300 yd³/acre)

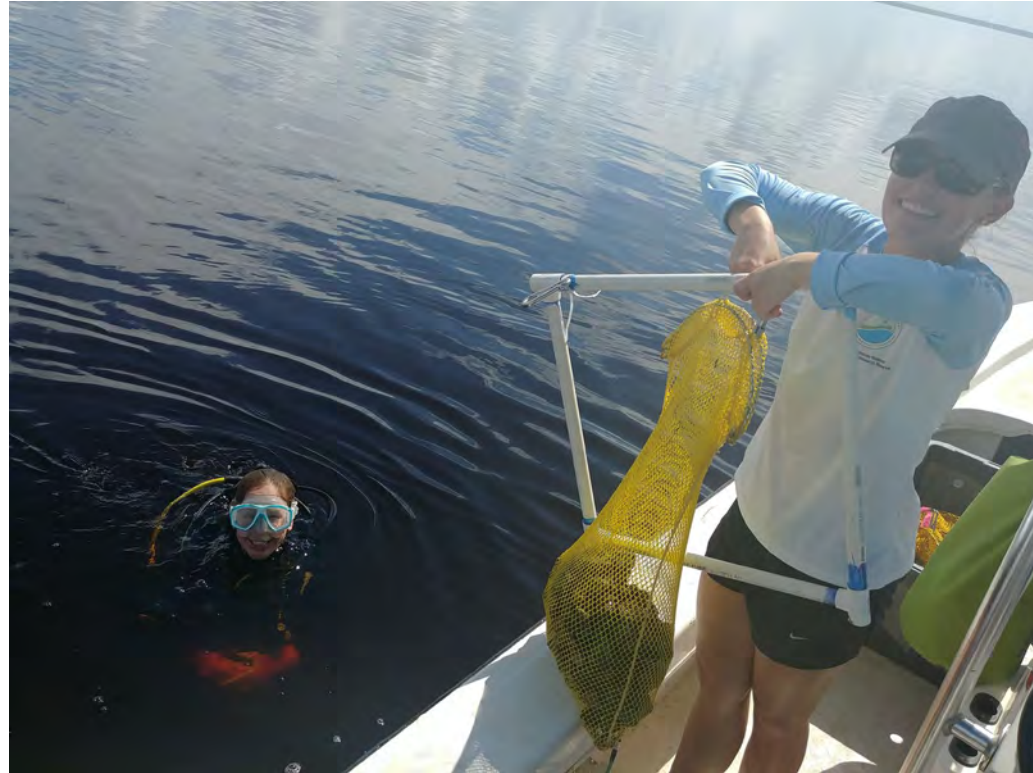
- **2015: Natural Resource Damage Assessment (NRDA) Oyster Cultch Recovery Project**
 - 24,840 yds³ fossilized shell on 16 debilitated oyster reefs (124 acres @ 200 yd³/acre)
 - Mapping and monitoring
- **2017: Gulf Coast Ecosystem Restoration Council (GCERC or RESTORE)**
 - 95,500 yd³ lime rock aggregate on 14 debilitated oyster reefs (317 acres @ 300 yd³/acre)
 - Mapping and monitoring
